Ferma-Carden Quarry

Lots 6-9 & West Half of Lot 10, Concession IX, Carden Township

Environmental Impact Assessment

Niblett Environmental Associates Inc.

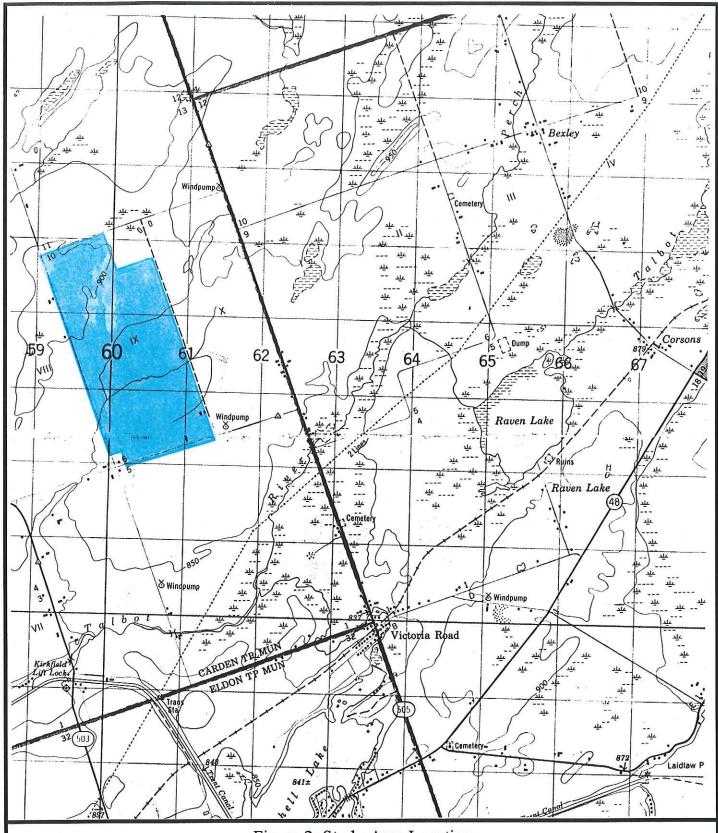
Figure 2: Study Area Location

The southern and northern boundaries of the property are Carden Line 5/6 (McNamee Road or Side Road 5/6) and Carden Line 10/11. The western and eastern boundaries are Concession Road IX and an unopened road allowance between Concessions IX and X. An intermittent tributary of the Talbot River traverses the property in an east to west direction. Figure 2 shows the location of the site in relation to local topographical features and road systems.

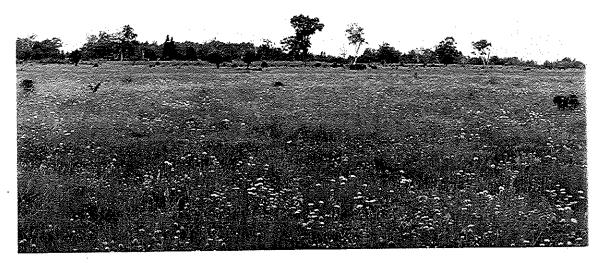
Photograph 1. Westward view of vegetation community no. 1 - part of proposed north extraction area (02 July 1993)

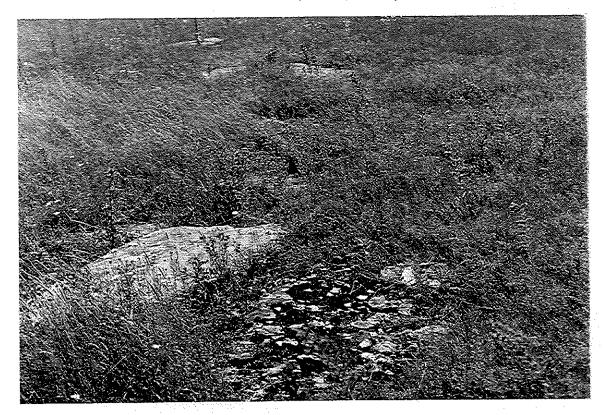
Photograph 2. Exposed limestone of alvar habitat in vegetation community no. 1 - part of eastern 400 metre setback zone (02 July 1993)

The drier sections of this unit had exposed limestone flat rock and low rocky ridges. The flat, exposed limestone bedrock sections were inundated with water in late spring and dry during the summer months. Typical plant species found in these sections included silvery cinquefoil (*Potentilla argentea*), mossy stonecrop (*Sedum acre*), wild columbine (*Aquilegia canadensis*), common mullein (*Verbascum thapsus*), pearly everlasting (*Anaphalis margaritacea*), Bicknell's crane's-bill (*Geranium bicknellii*), blue-eyed grass (*Sisyrinchium montanum*), Deptford pink (*Dianthus armeria*) and mosses.

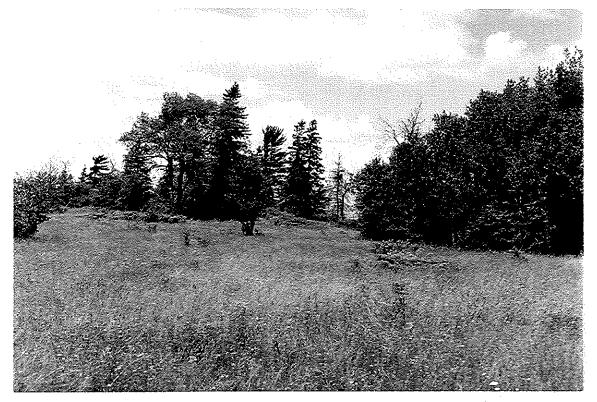
Photograph 3. South end of vegetation community no. 2 - ridge of white pine, white spruce, white birch and common juniper (02 July 1993)

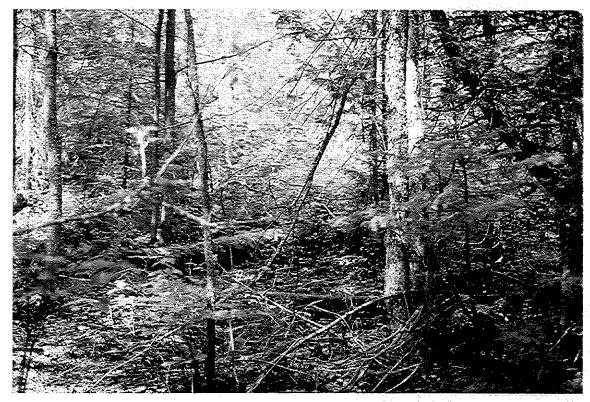
Photograph 4. Inside view of vegetation community no. 3 - eastern white cedar, poplars, balsam fir, white pine and white birch (02 July 1993)

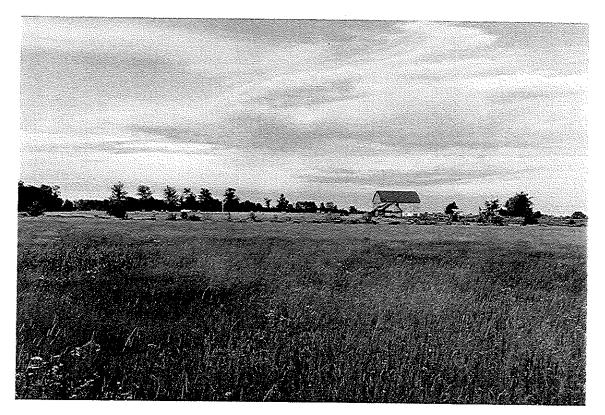
Photograph 5. Eastward view of vegetation community no. 7 - farmstead and hay field - in proposed south extraction area (21 July 1993)

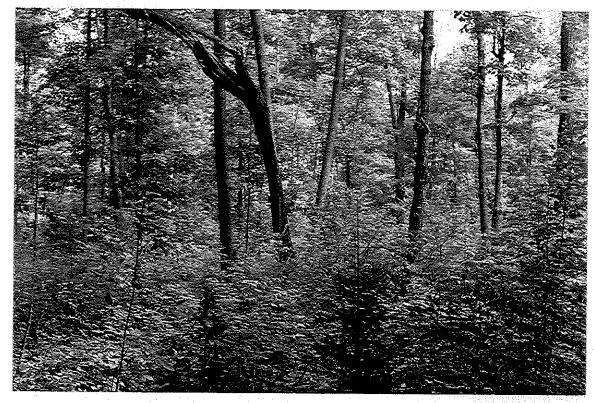
Photograph 6. High-graded section of hardwood bush with hard maple, white ash, basswood and dense shrub layer - part of subunit 9a (21 July 1993)

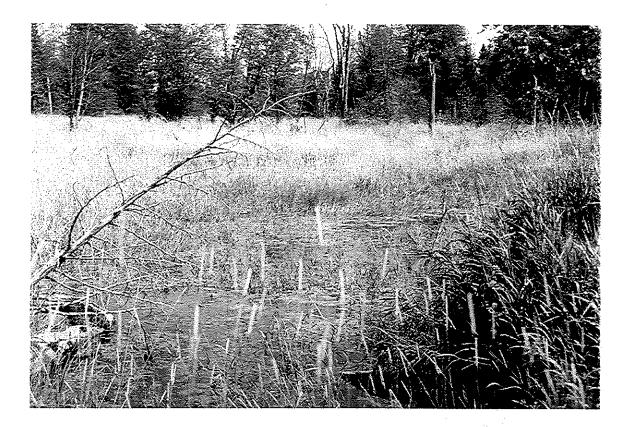
Photograph 7. Remnant beaver pond in vegetation community no. 14 with graminoids, sedges, ferns and open water (02 July 1993)

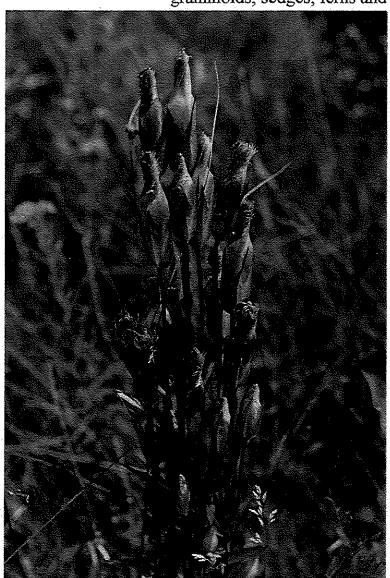
Photograph 8. Fringed gentian (Gentiana crinita), regionally rare plant species found in vegetation community no. 1 (27 August 1993)

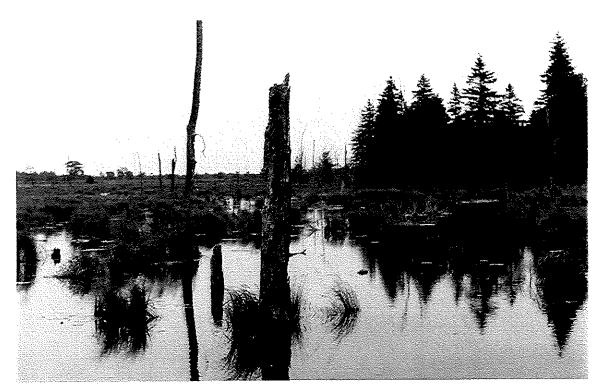
Photograph 9. Wetland habitat on Talbot River tributary along central eastern edge of property (02 July 1993)

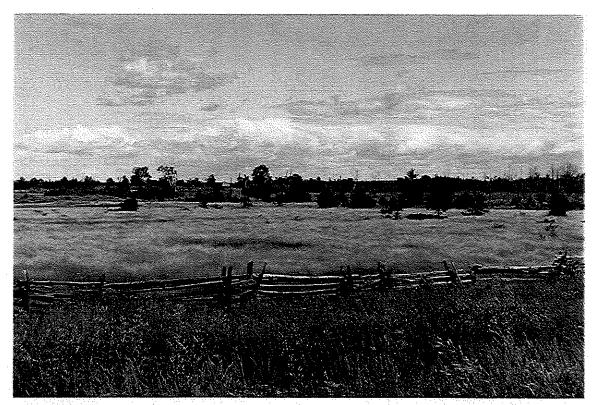
Photograph 10. Grassland and hawthorn-conifer scrubland on site vicinity lands to the east of the proposed north extraction area (02 July 1993)
